1. REPORT DATE (DD-MM-YYYY) 28-02-2003		2. REPORT TYPE A005 DATA ITEM		3. DATES COVERED (From - To) 01-04-1998 TO 28-02-2003	
4. TITLE AND SUBTITLE FINAL REPORT for Contract DAAE07-98-C-M012 (PART 3 OF 3) -Evaluation of Alternate Driveshaft Configurations for the FMTV Program				5a. CONTRACT NUMBER DAAE07-98-C-M012	
				5b. GRANT NUMBER	
				5c. PROGRAM ELEMENT NUMBER	
				5d. PROJECT NUMBER

14. ABSTRACT EVALUATIONS OF CANDIDATE DRIVESHAFTS FOR THE FMTV PROGRAM FROM DANA, ARVIN MERITOR (2 DESIGNS), AND GKN WERE CONDUCTED. THE EVALUATIONS INCLUDED INSTRUMENTED ROAD TESTING, A 1000-MILE DURABILITY TEST THAT INCLUDED HIGH SPEED DRIVING AND SUBMERSION, LABORATORY MEASUREMENTS, AND DADS MODELING. THE DRIVESHAFTS WERE (UN)BALANCED TO THEIR MANUFACTURERS PRODUCTION LIMITS PRIOR TO EVALUATION AND THEN TESTED ON THE VEHICLE USING A SPECIAL TRANSFER CASE TRANSDUCER CAPABLE OF MEASURING DRIVESHAFT DYNAMIC FORCES. A PRINCIPLE FOCUS OF THE PROGRAM INCLUDED SEVERAL METHODS OF MEASURING INSTALLED CRITICAL SPEED.

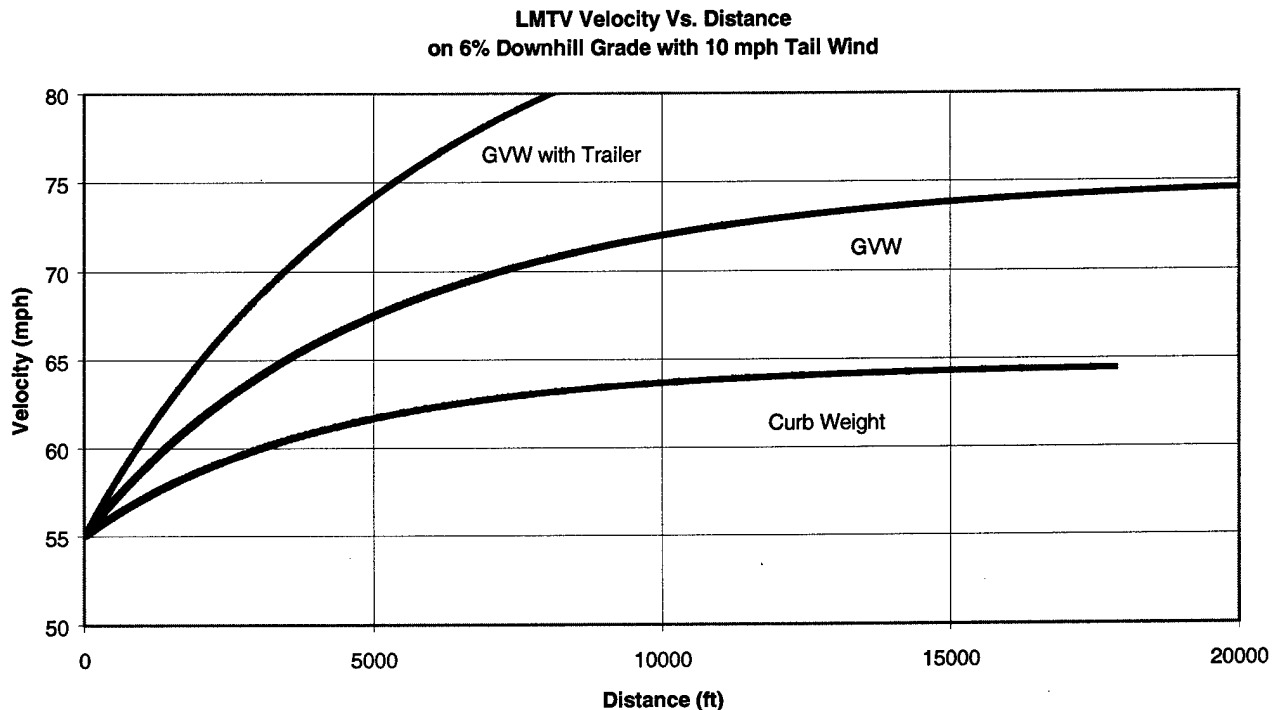
Figure 12

A typical output chart from the model is shown in Figure 12.

It can be seen that an LMTV at GVW, can easily achieve 70 mph on grades found on the US interstate highway system. The AØ vehicles were built with no engine braking hardware. The A1 vehicles have an engine exhaust brake, which can be turned off by the driver. This analysis is representative of all AØ vehicles as well as the A1 vehicles with the exhaust brake off. The use of a trailer further increases speeds.

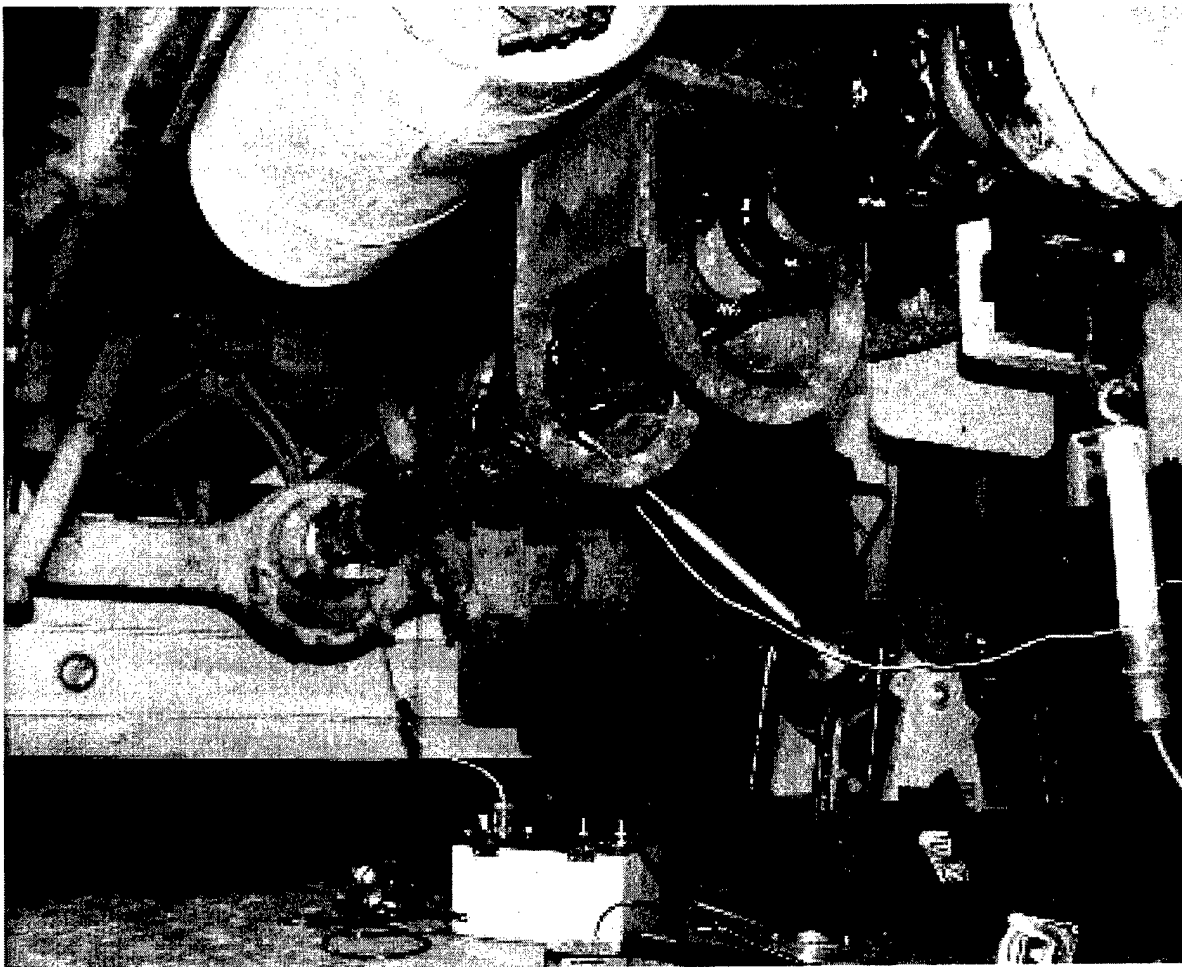
Figure 13 In-Vehicle Shaker Test

It is necessary to provide guards to prevent excessive vehicle damage if the vehicle is to be driven near critical speed. The LMTV was fitted with appropriate guards and measurement channels for this test.

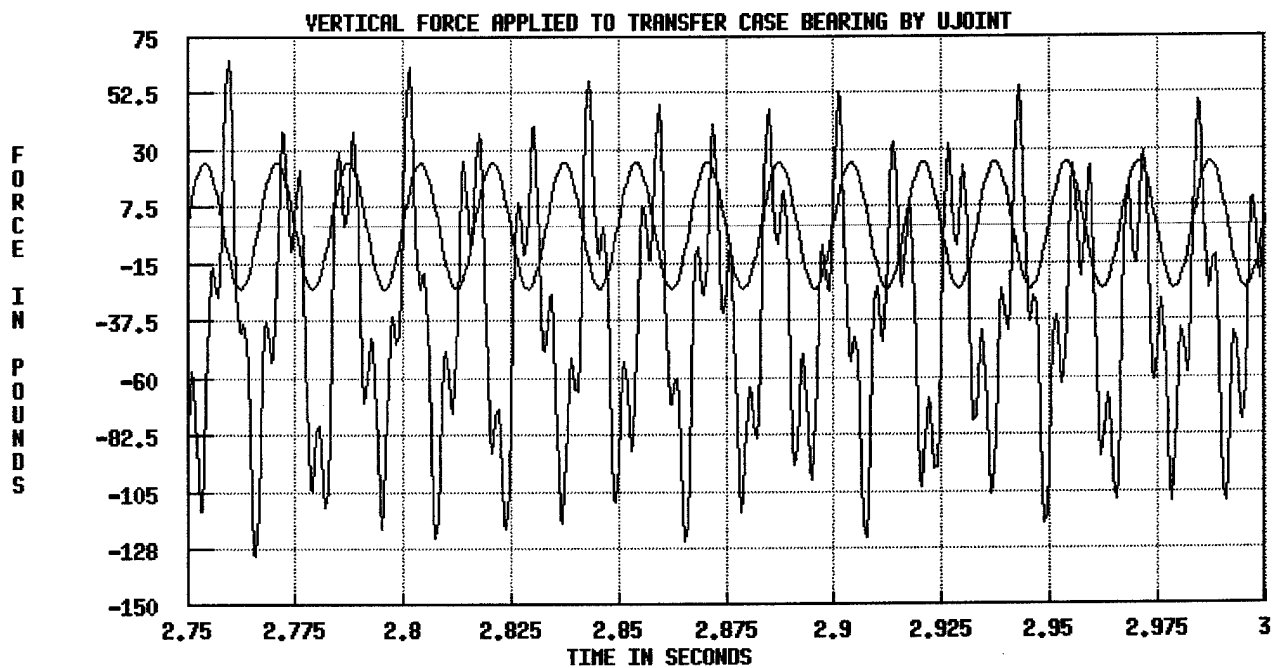
FIGURE 1

The vertical force trace for V20srVCSgb0ubgbrs.def, figure1, shows a complex waveform with elements related to the rotational speeds and with a signal changing faster than the rotational speed. Its FFT, figure2, shows a signal at the critical speed of 71 HZ, the residual response to the startup transient. It shows weaker signals at the second and fourth orders of rotational speed. These are generated by the twice per revolution rotational acceleration and deceleration of the shafts inertia due to ujoint's operating angle. Both of these signal sources will be treated in more detail later. The addition of unbalance (V20srVCSgb1ubgbrs.def) adds a very strong component at first order of revolution. The force trace, figure3, shows a beat between that and the residual response to the startup transient. The amplitude of the residual response and that due to the rotational acceleration/deceleration remains about the same as shown by both FFTs. The amplitude of the once per revolution caused by the unbalance is the dominant signal in the second FFT, figure 4.

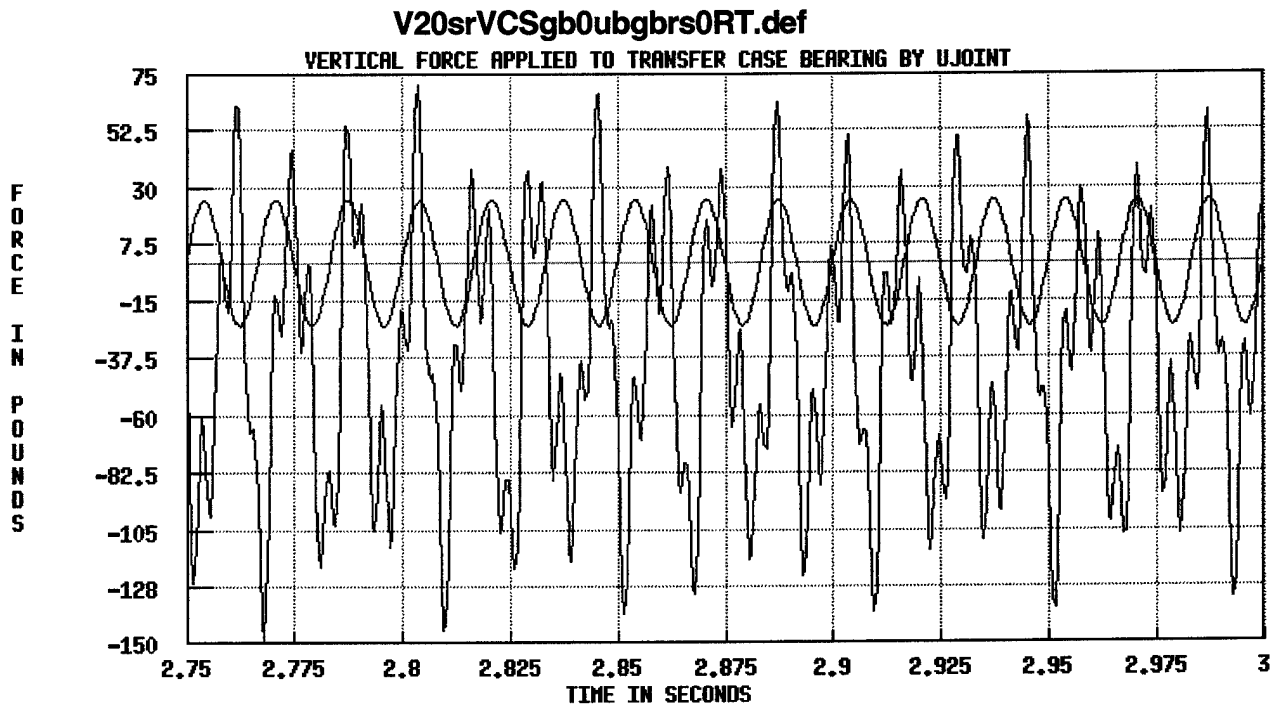
FIGURE 7

The vertical force trace for V20srVCSgb0ubgbrs0RT.def, figure 7, (no load torque) shows a complex waveform. It's FFT, figure 8, shows it is comprised of signals at 70.3 Hz @ 35.8 units of amplitude, 120 Hz @ 7.8 units and 240 Hz @ 17 units. The 70.3 Hz signal is, as described earlier, the residual response from the startup transient. The 120 Hz and 240 Hz signals are from the second and fourth order forces generated by the twice per revolution rotational acceleration and deceleration of the shaft. The driving torque graph, figure 9, shows that twice per revolution torque. Note that it is symmetric around the zero axis.

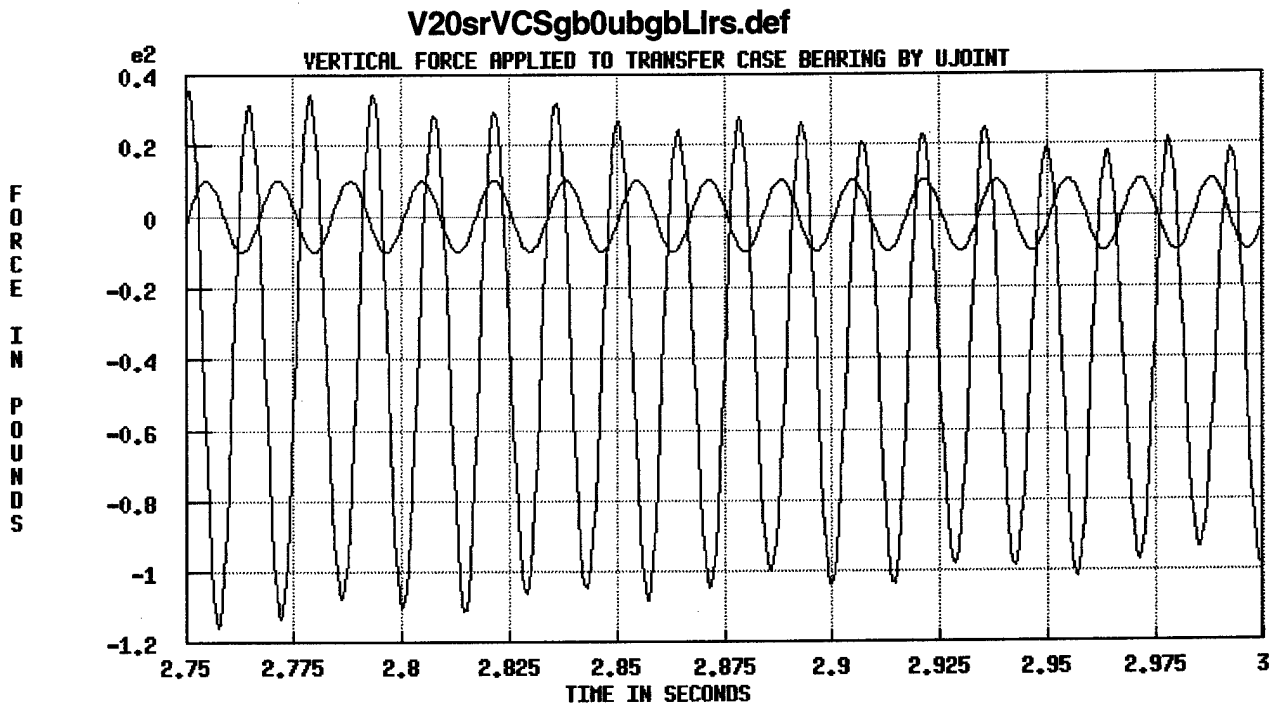
FIGURE 16

In run V20srVCSgb0ubgbLlrs.def, figure 16, (low shaft inertia) the vertical force is about 140 lbs. peak to peak. This is somewhat lower than with the standard inertia. The force is biased negatively due to the static weight of the shaft. Note that the force is not locked to rotation. The force FFT, figure 17, shows a peak at 70.3 Hz from the residual response to the startup transient. It also shows a weak peak at 120 Hz, second order of rotation. The driving torque, figure 18, applied to the tube is about 56 in-lbs. peak to peak biased upwards by the 240 in-lbs. drag torque. It is a second order signal.

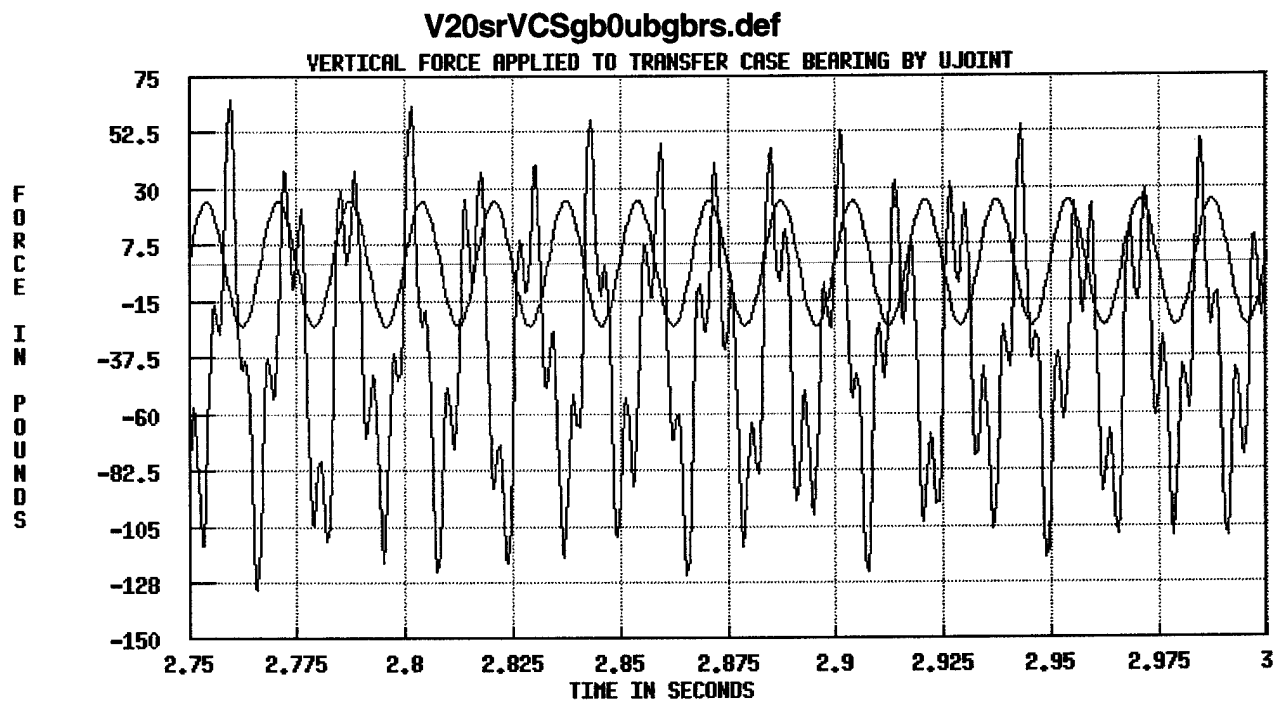
FIGURE 19

The vertical force is about 175 lbs. peak to peak in run V20srVCSgb0ubgbLrs.def, figure 19 (standard shaft inertia). The weight bias remains. The force waveform is more complex due to the stronger second and fourth order content as shown by the FFT, figure 20. The required driving torque, figure 21, is much higher but continues to show the drag torque bias.

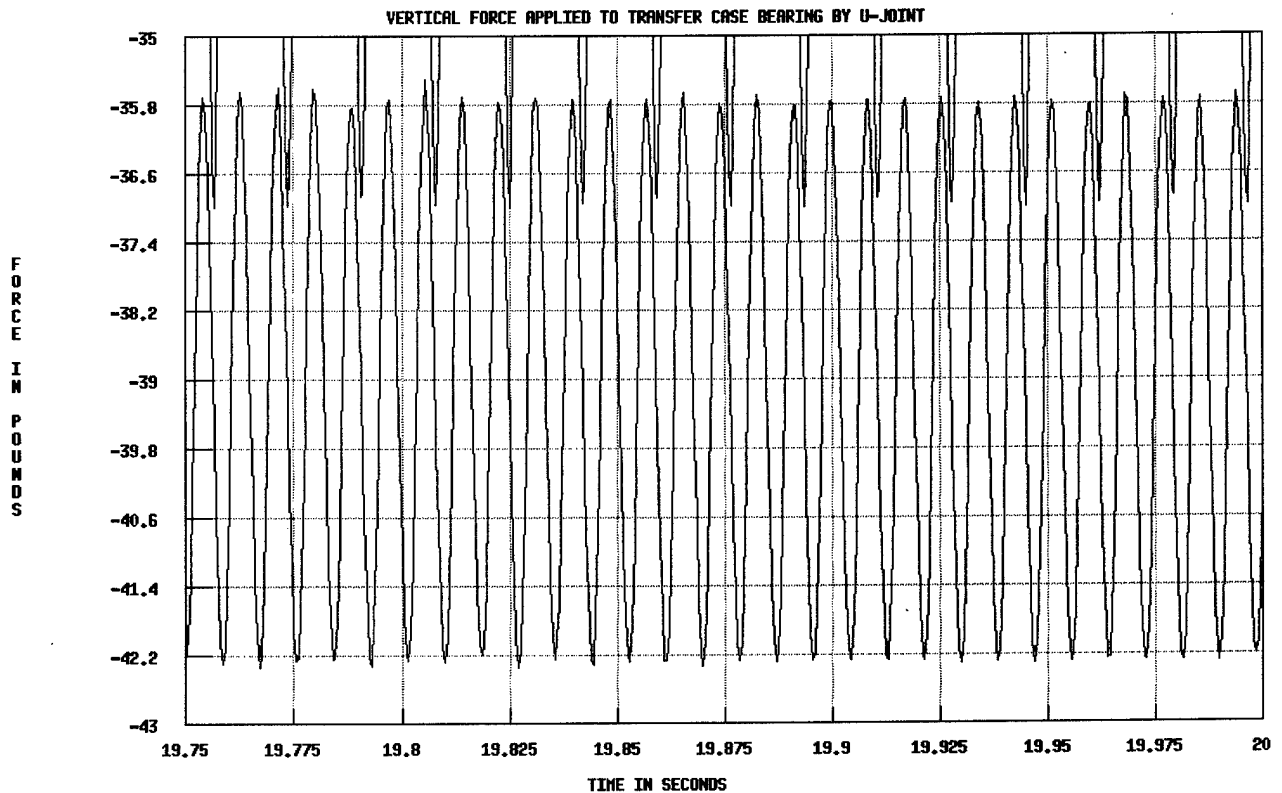
FIGURE 25

Both vertical force traces show the vertical force bias due to gravity of about 39 plus lbs. The force trace for the run with drag torque, figure 25, is the sum of the reaction components to both drag torque and the twice per rev shaft velocity change. The AC force is about 7-lbs. peak to peak, predominately second order. The AC force for the run without drag torque, figure 28, is about 0.4 lbs. peak to peak, predominately fourth order. The required driving torque, figure 27, for the run with drag has a 56 in-LB peak to peak second order AC component added to a 240 in-lbs. DC component. The required driving torque without drag, figure 30, is also 56 in-lbs. peak to peak second order AC without a DC component. The FFT for the run with drag, figure 26, shows a second order component and a weaker fourth order. The no drag FFT, figure 29, shows weak second and fourth order components from the low shaft inertia being accelerated twice per rev. However the fourth order is about twice the second order component.

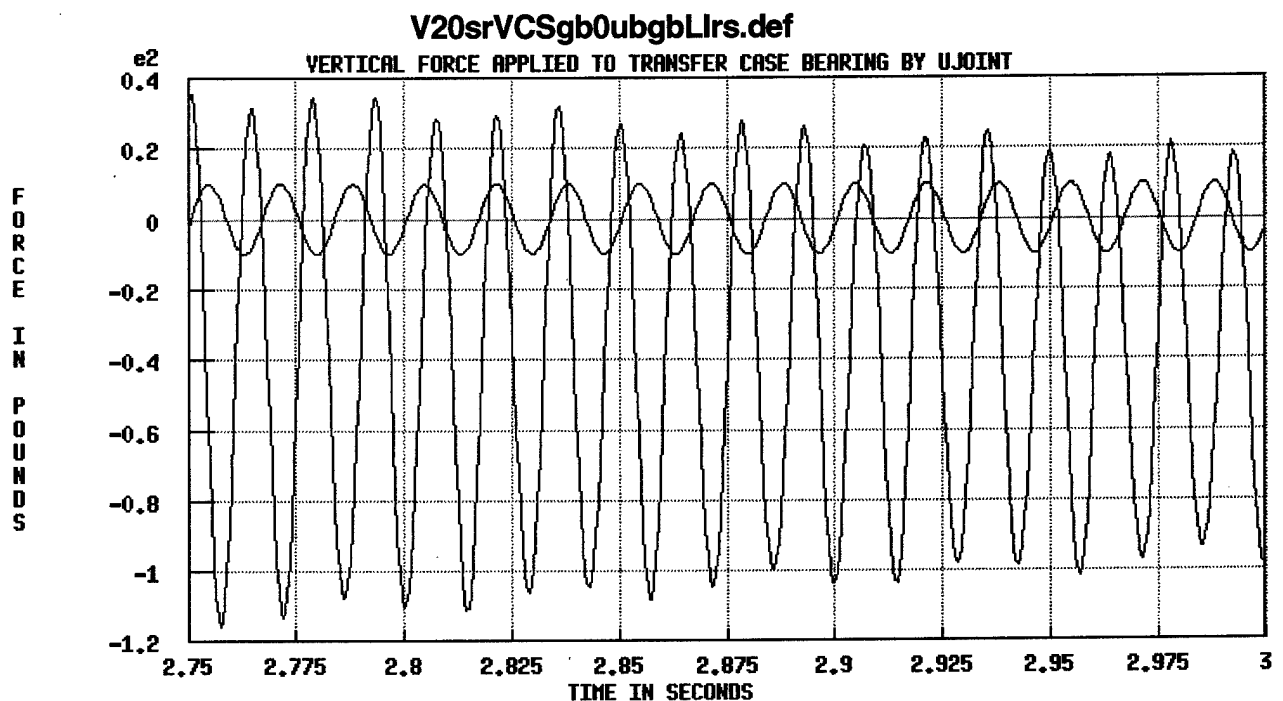
FIGURE 31

Figure 31 shows a decaying response to the startup transient with an additional second order force. This is also shown by its FFT, figure 32. Figure 33 shows the second order driving torque required by the drag torque and small shaft inertia. Figure 34 displays a more complex force waveform with a strong beat pattern. Figure 35, its FFT, shows a large component at 60 Hz caused by the unbalance. The component at 70 + Hz from the decaying response to the startup transient has increased by 25 % but is less than half of the 60 Hz component. These two are the source of the beat. The magnitude of the residual response is consistent with that generated by broad band noise input to the drive train. The second and fourth order components are nearly unchanged between the two runs, however addition of the unbalance has added a slight third order component.

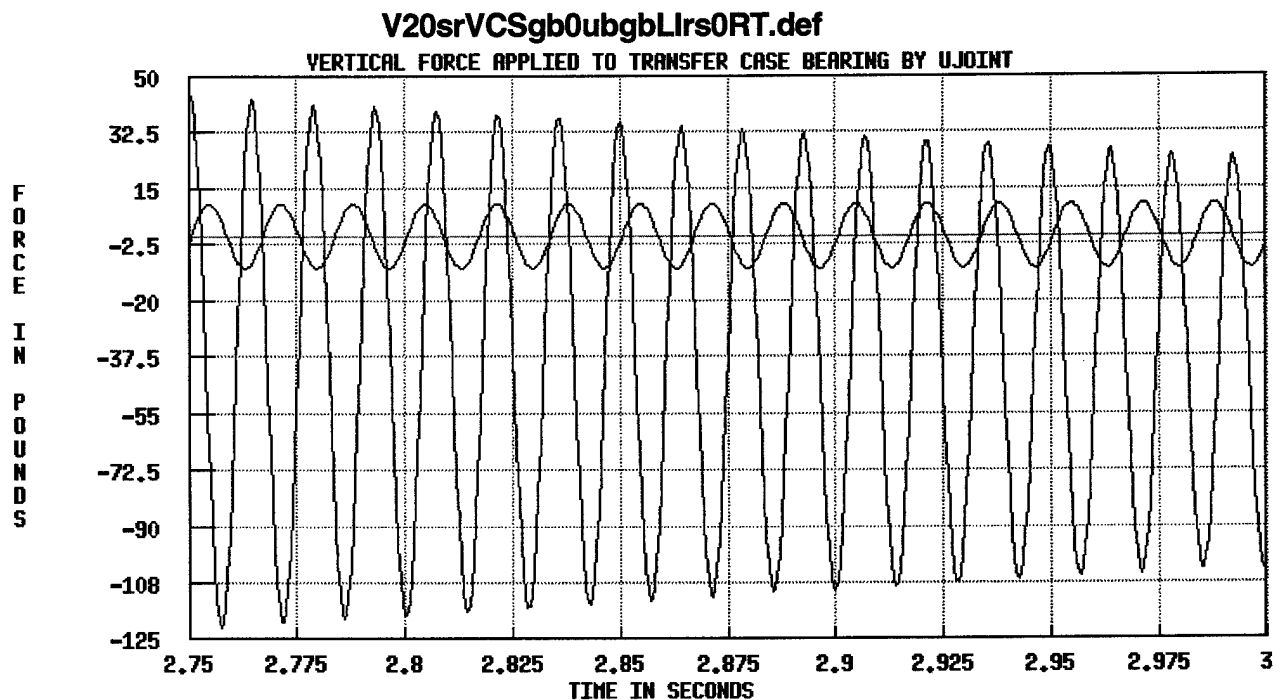
FIGURE 37

Figure 37, the force trace, shows the signature of the decaying transient. Its FFT, figure 38, confirms that it is the strongest signal present. A zoomed FFT, not shown, shows small levels of signal at second and fourth order. A small signal also appears at slightly above third order. Figure 39, the driving torque signal, is clearly second order, not related to the transient. It is about 56.1 in-lbs. peak-to-peak. It is the torque required to accelerate and decelerate the small shaft inertia as well as replace energy dissipated in damping. Figure 40 shows the forces after the startup transient has fully decayed. It is a mixture of second and fourth order at low magnitude. A zoomed FFT, figure 41, shows low levels of second and fourth order. These are about half of their counterparts discussed above. Also there is no energy around third order. The driving torque signal, figure 42, is about 52.7 in-lbs. peak-to-peak. System geometry changes as the startup transient decays and less energy is dissipated in damping.

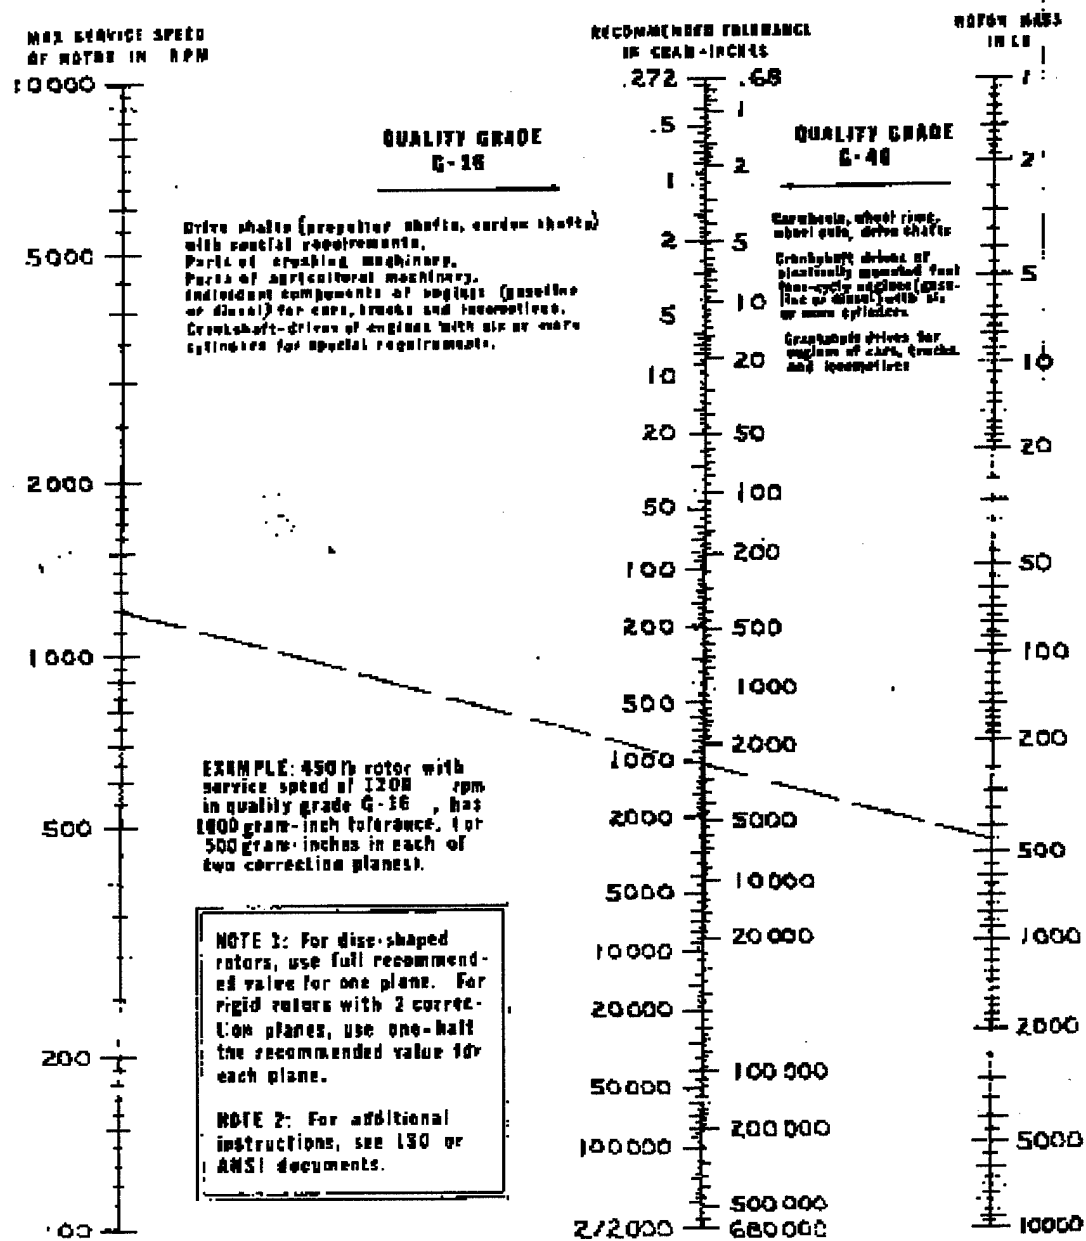
Fig 5-9 BALANCE TOLERANCE NOMOGRAM FOR G 16 & G 40

Based on ISO 1909, and ANSI S2.19
